**Flood Control Project Maintenance
Levee Inspections**

Spring 2012 Levee Inspection Results

Reclamation District No. 2063 Crows Landing

Waterway			Bank	Unit Miles
Unit No. 01 San Joaquin River			Right	10.63
	Spring (March - May)	Summer (June - August)	(September - November) Fall	Winter (December - February)
Unit Maintenance Rating (Fall Only)				
Date of Inspection	5/22/2012 - 5/22/2012			
DWR Inspector	Richard Willoughby			
Accompanied By

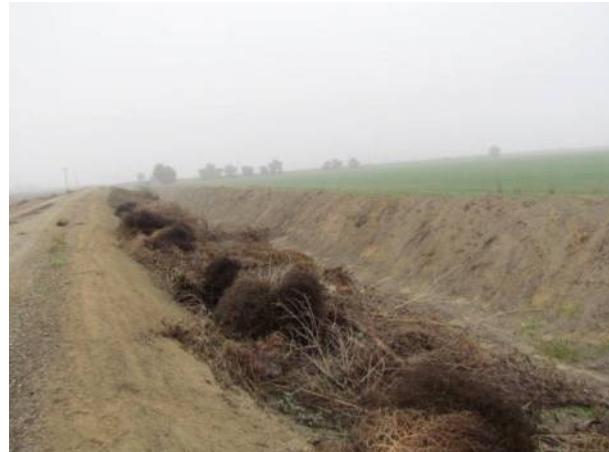
Levee Mile Report Line	7
Start Levee Mile	0.03
End Levee Mile	0.49
Location	Land Side
Category	Earthen Levee
Item	Encroachments
Looking north at ditch on landside berm and toe.	
richard_s_20120313_124.jpg

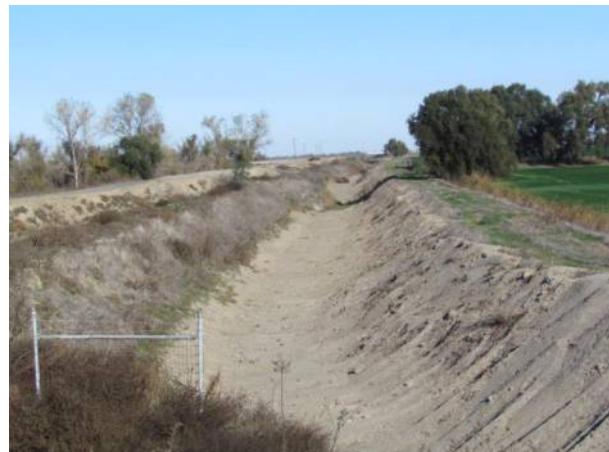
Levee Mile Report Line	7
Start Levee Mile	0.03
End Levee Mile	0.49
Location	Land Side
Category	Earthen Levee
Item	Encroachments
Looking south at canal-ditch at landside berm and toe.	
richard_s_20120313_125.jpg

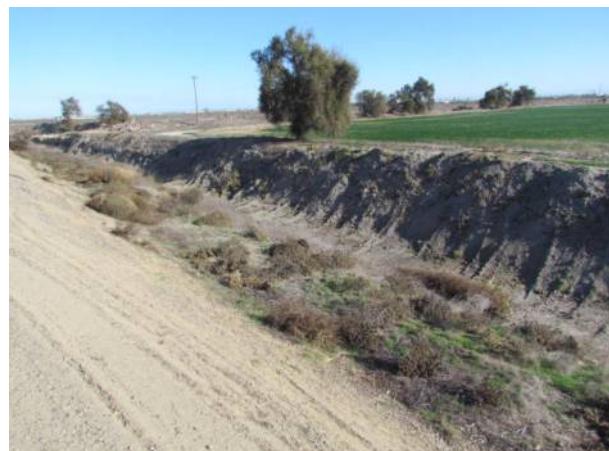
Levee Mile Report Line	7
Start Levee Mile	0.03
End Levee Mile	0.49
Location	Land Side
Category	Earthen Levee
Item	Encroachments
Looking northeast at canal-ditch on landside berm.	
richard_s_20120313_126.jpg

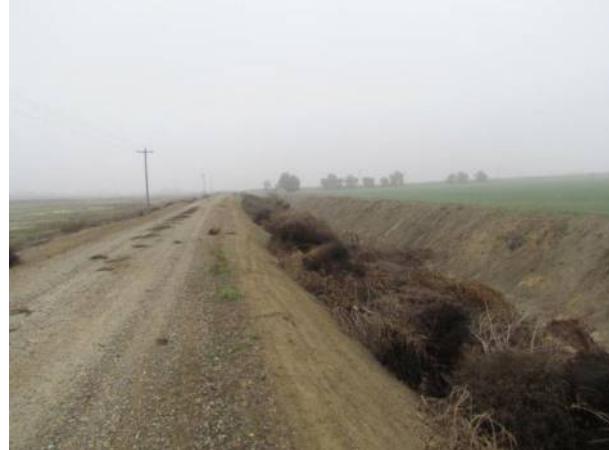
Levee Mile Report Line	8
Start Levee Mile	0.14
End Levee Mile	0.22
Location	Land Side
Category	Earthen Levee
Item	Encroachments
Looking north at prunings stacked on landside toe and berm.	
richard_s_20120313_123.jpg

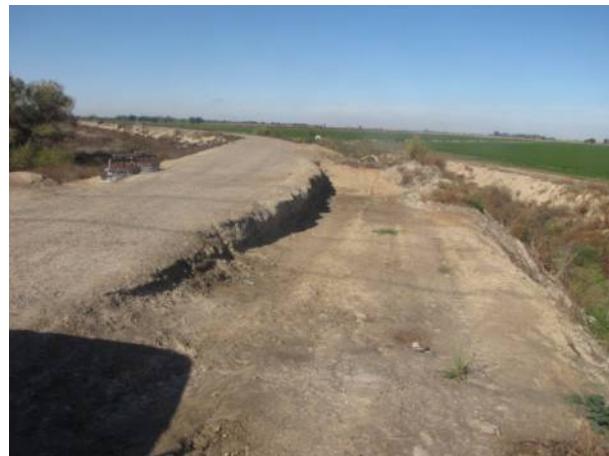
Levee Mile Report Line	9
Start Levee Mile	1.35
End Levee Mile	1.35
Location	Land Side
Category	Earthen Levee
Item	Encroachments
Looking north at ramp and equipment working pad on landside slope with a 18-20" vertical cut at shoulder.	
richard_s_20120313_112.jpg

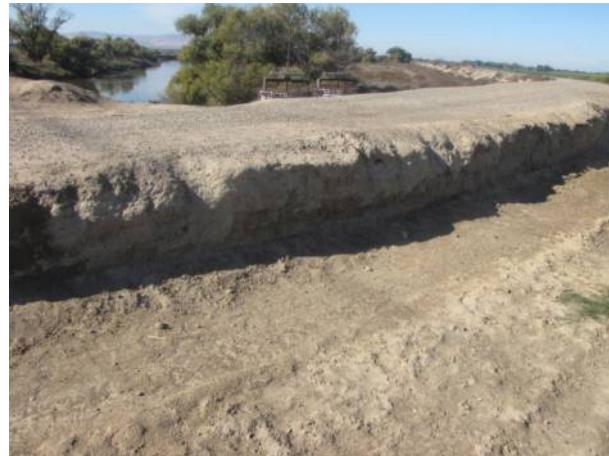
Levee Mile Report Line	9
Start Levee Mile	1.35
End Levee Mile	1.35
Location	Land Side
Category	Earthen Levee
Item	Encroachments
Looking west at 18-20" vertical cut for ramp on landside shoulder and slope	
richard_s_20120313_113.jpg

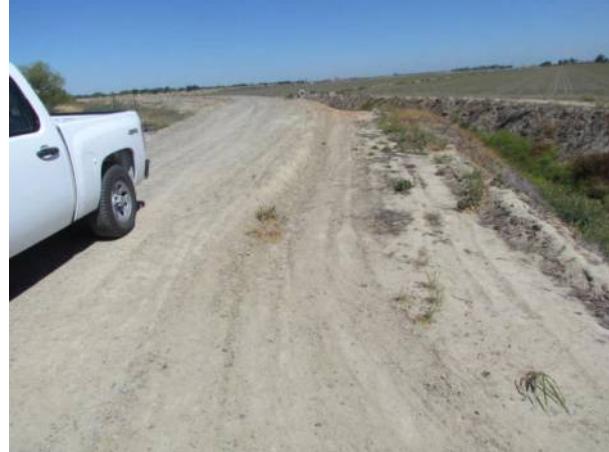
Levee Mile Report Line	9
Start Levee Mile	1.35
End Levee Mile	1.35
Location	Land Side
Category	Earthen Levee
Item	Encroachments
Looking north at vertical cut on landside shoulder and slope (Spring 2012)	
richard_s_20120529_445.jpg

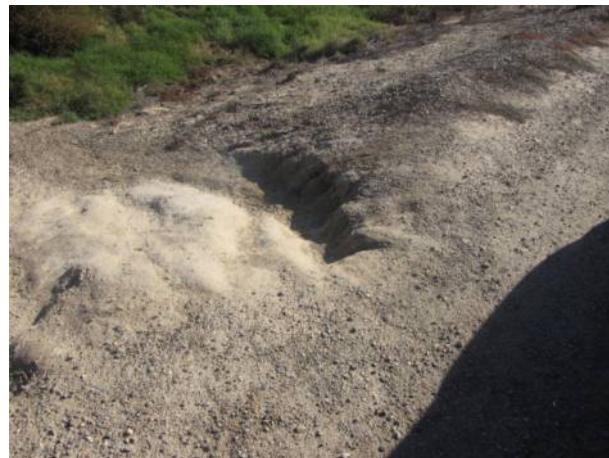
Levee Mile Report Line	11
Start Levee Mile	1.54
End Levee Mile	1.54
Location	Land Side
Category	Earthen Levee
Item	Slope Stability
Looking east at landside slope damage (six to eight inch erosion) by vehicle	
richard_s_20120313_114.jpg

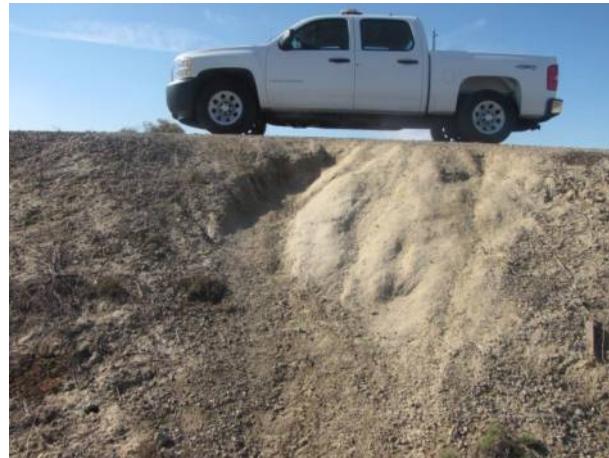
Levee Mile Report Line	11
Start Levee Mile	1.54
End Levee Mile	1.54
Location	Land Side
Category	Earthen Levee
Item	Slope Stability
Looking west at landside slope damage cause by vehicle traffic.	
richard_s_20120313_115.jpg

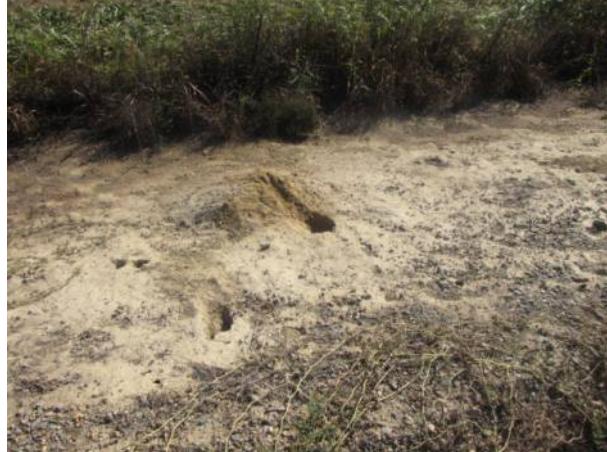
Levee Mile Report Line	13
Start Levee Mile	1.69
End Levee Mile	1.69
Location	Land Side
Category	Earthen Levee
Item	Animal Control
Looking east at squirrel holes on landside slope.	
richard_s_20120313_116.jpg

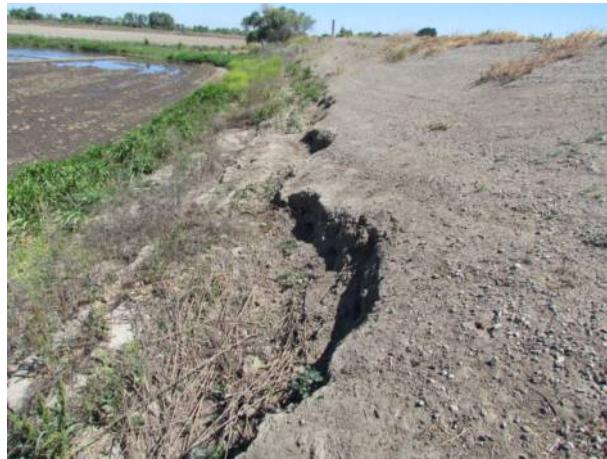
Levee Mile Report Line	14
Start Levee Mile	1.88
End Levee Mile	1.92
Location	Water Side
Category	Earthen Levee
Item	Erosion / Bank Caving
Looking north at erosion along waterward slope.	
richard_s_20120529_446.jpg

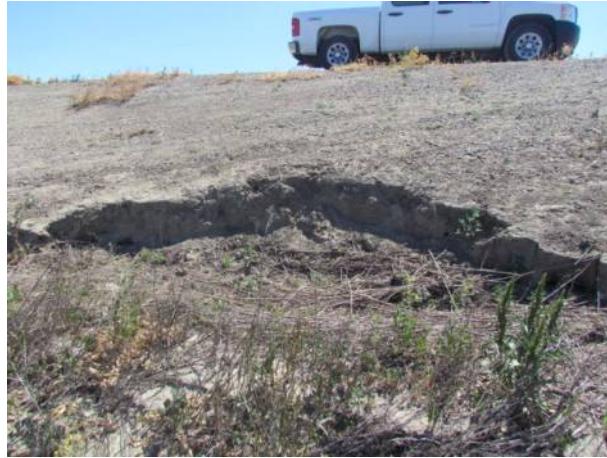
Levee Mile Report Line	14
Start Levee Mile	1.88
End Levee Mile	1.92
Location	Water Side
Category	Earthen Levee
Item	Erosion / Bank Caving
Looking east at erosion along waterward slope.	
richard_s_20120529_447.jpg

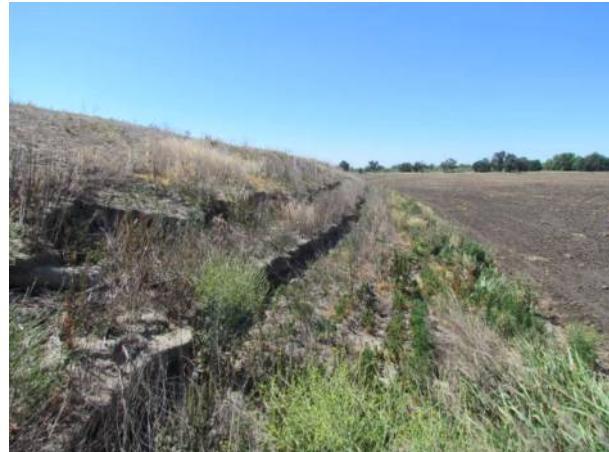
Levee Mile Report Line	14
Start Levee Mile	1.88
End Levee Mile	1.92
Location	Water Side
Category	Earthen Levee
Item	Erosion / Bank Caving
Looking south at erosion along waterward slope.	
richard_s_20120529_448.jpg

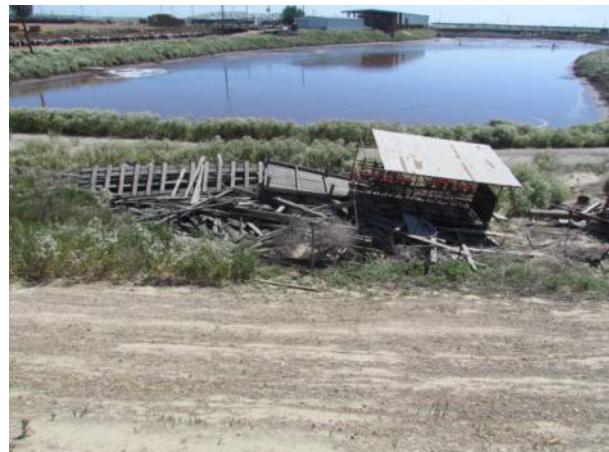
Levee Mile Report Line	15
Start Levee Mile	1.95
End Levee Mile	1.95
Location	Land Side
Category	Earthen Levee
Item	Encroachments
Looking east at garbage at landside toe.	
richard_s_20120529_449.jpg

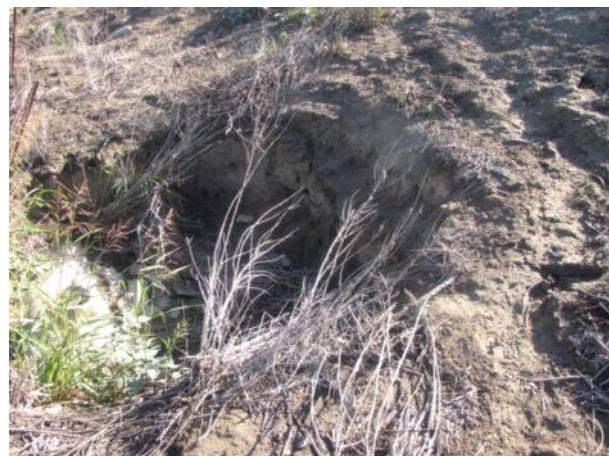
Levee Mile Report Line	16
Start Levee Mile	2.31
End Levee Mile	2.47
Location	Land Side
Category	Earthen Levee
Item	Erosion / Bank Caving
Looking west at slope caving around concrete irrigation pipe on landside toe.	
richard_s_20120313_117.jpg

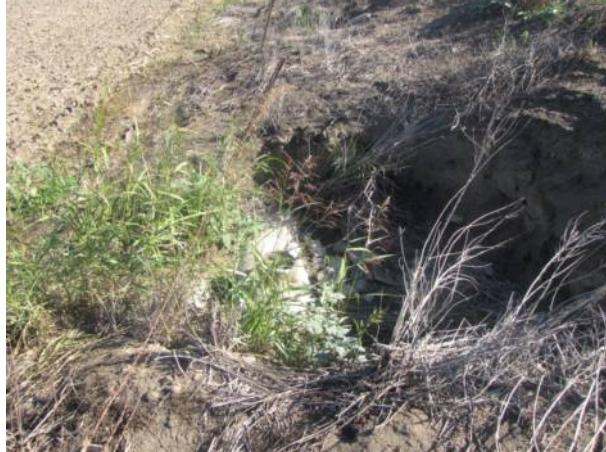
Levee Mile Report Line	16
Start Levee Mile	2.31
End Levee Mile	2.47
Location	Land Side
Category	Earthen Levee
Item	Erosion / Bank Caving
Looking south at additional caving around concrete pipe.	
richard_s_20120313_118.jpg

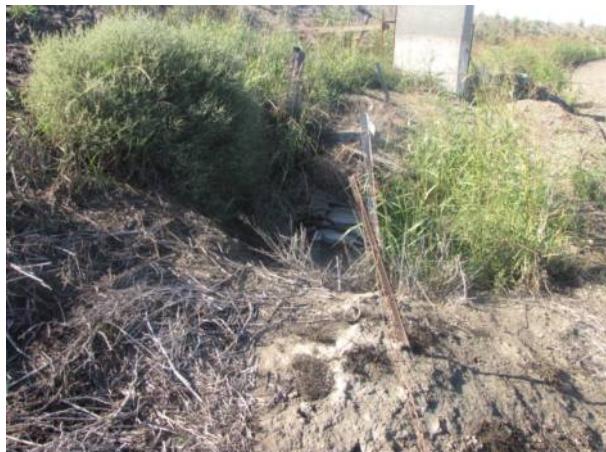
Levee Mile Report Line	16
Start Levee Mile	2.31
End Levee Mile	2.47
Location	Land Side
Category	Earthen Levee
Item	Erosion / Bank Caving
Looking north at site #1 caving around pipe on landside slope.	
richard_s_20120313_119.jpg

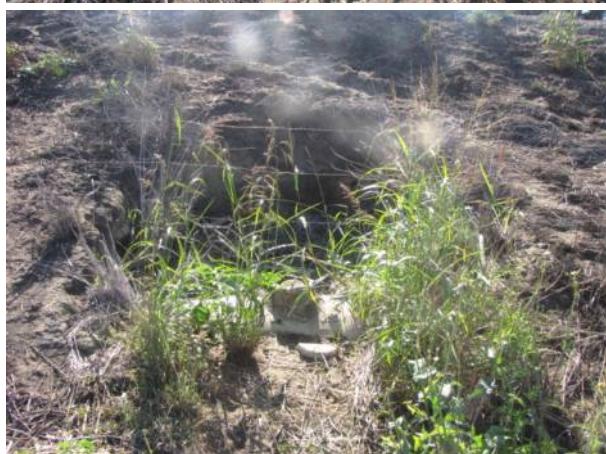
Levee Mile Report Line	16
Start Levee Mile	2.31
End Levee Mile	2.47
Location	Land Side
Category	Earthen Levee
Item	Erosion / Bank Caving
Looking west at caving around concrete pipe at site #3.	
richard_s_20120313_120.jpg

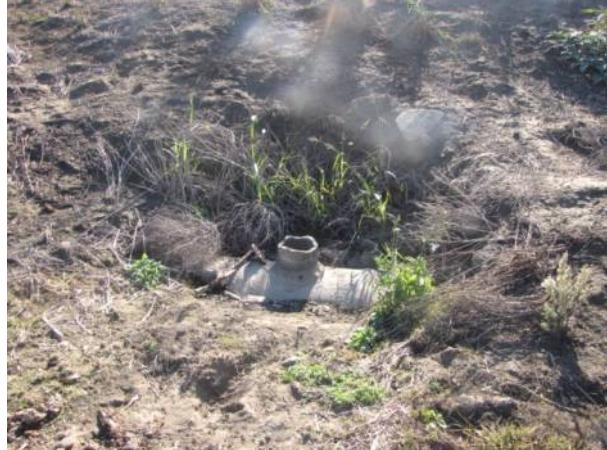
Levee Mile Report Line	16
Start Levee Mile	2.31
End Levee Mile	2.47
Location	Land Side
Category	Earthen Levee
Item	Erosion / Bank Caving
Looking west at concrete irrigation pipe that runs along landside toe.	
richard_s_20120313_121.jpg

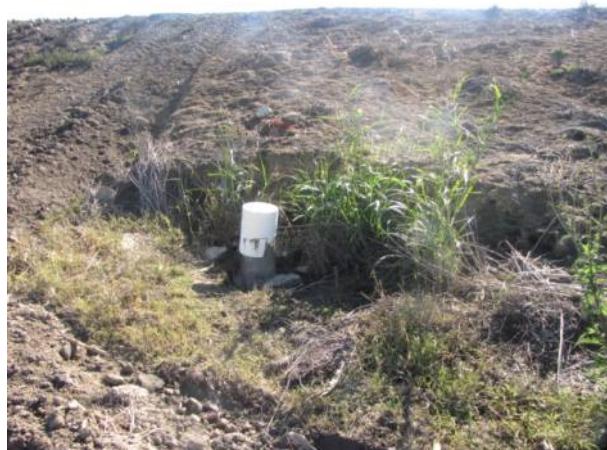
Levee Mile Report Line	16
Start Levee Mile	2.31
End Levee Mile	2.47
Location	Land Side
Category	Earthen Levee
Item	Erosion / Bank Caving
Looking southwest at site # 4 of slope caving around concrete irrigation pipe at landside toe.	
richard_s_20120313_122.jpg

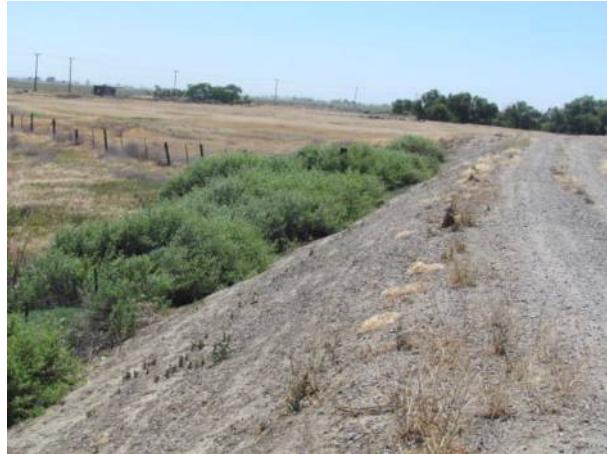
Levee Mile Report Line	18
Start Levee Mile	2.53
End Levee Mile	2.56
Location	Land Side
Category	Earthen Levee
Item	Vegetation
Looking south at dense vegetation on landside toe.	
richard_s_20120529_450.jpg

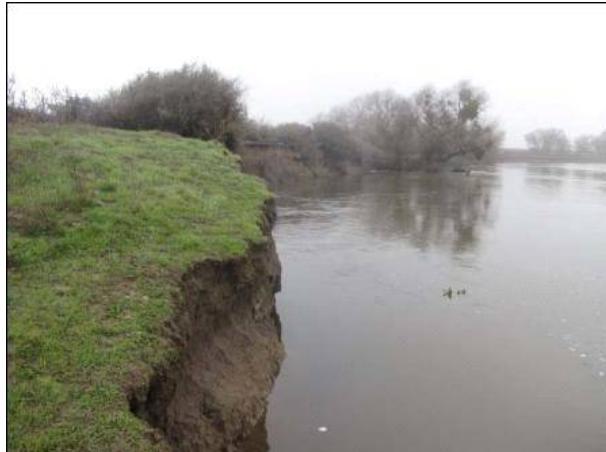
richard_s_20120313_136.jpg

Levee Mile Report Line	21
Start Levee Mile	3.07
End Levee Mile	3.26
Location	Water Side
Category	Supplemental
Item	DWR Erosion Survey

Looking south from station 0+00. Image taken by Herman Phillips

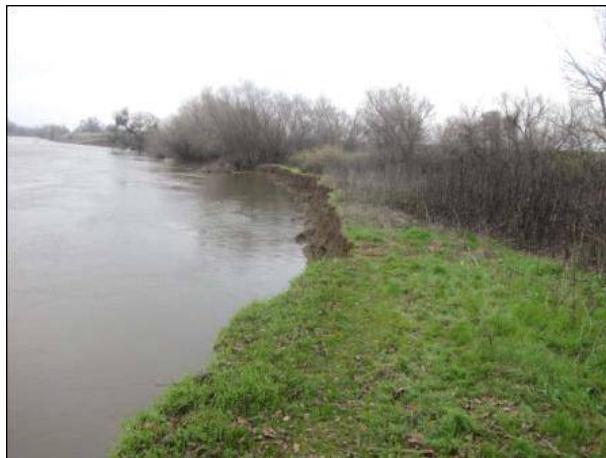
richard_s_20120313_137.jpg

Levee Mile Report Line	21
Start Levee Mile	3.07
End Levee Mile	3.26
Location	Water Side
Category	Supplemental
Item	DWR Erosion Survey

Looking north from station 10+00. Image taken by Herman Phillips

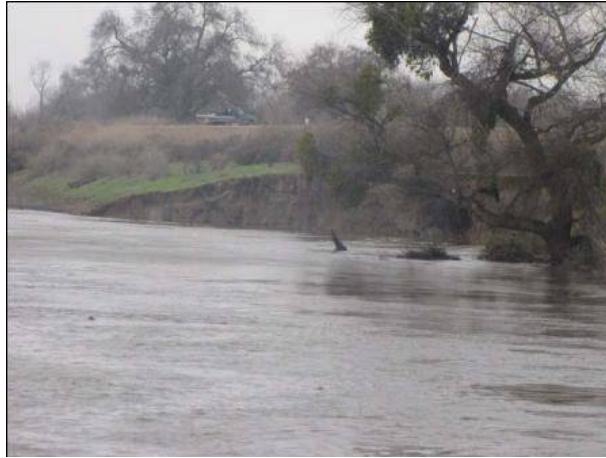
richard_s_20120313_138.jpg

Levee Mile Report Line	21
Start Levee Mile	3.07
End Levee Mile	3.26
Location	Water Side
Category	Supplemental
Item	DWR Erosion Survey

Looking north at station 0+00. Image taken by Herman Phillips

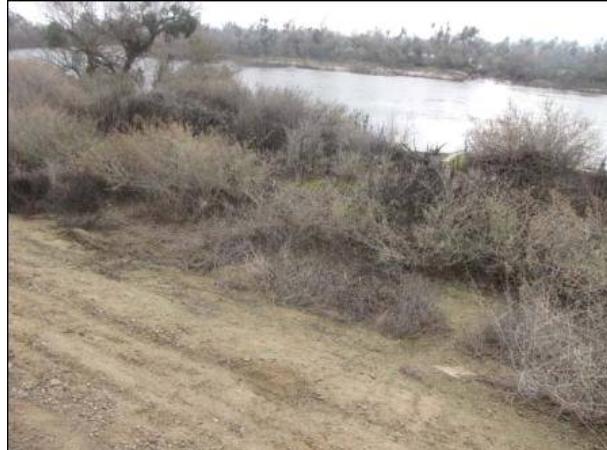
Levee Mile Report Line	21
Start Levee Mile	3.07
End Levee Mile	3.26
Location	Water Side
Category	Supplemental
Item	DWR Erosion Survey
Looking west at berm from station 1+00. Image taken by Herman Phillips	
richard_s_20120313_139.jpg

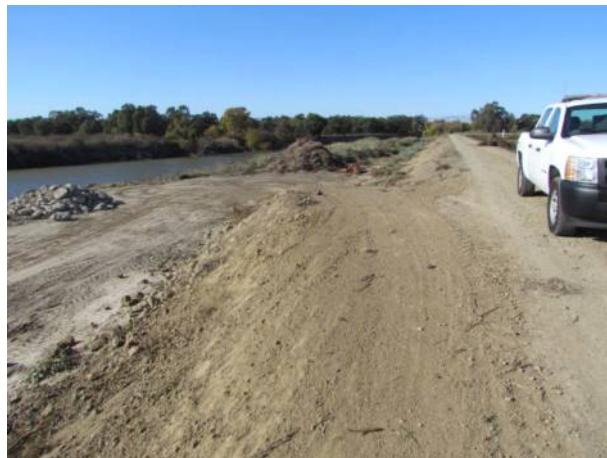
Levee Mile Report Line	22
Start Levee Mile	3.16
End Levee Mile	3.16
Location	Water Side
Category	Earthen Levee
Item	Encroachments
Looking south at unauthorized ramp on waterside slope.	
richard_s_20120313_132.jpg

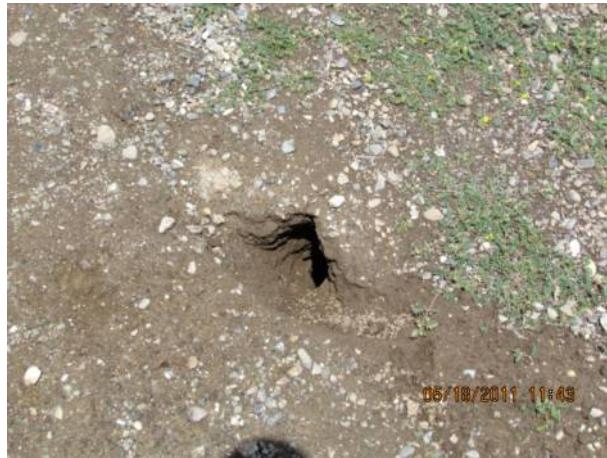
Levee Mile Report Line	25
Start Levee Mile	3.82
End Levee Mile	3.82
Location	Land Side
Category	Earthen Levee
Item	Animal Control
Looking at typical view of a squirrel hole on landside shoulder.	
richard_s_20120313_134.jpg

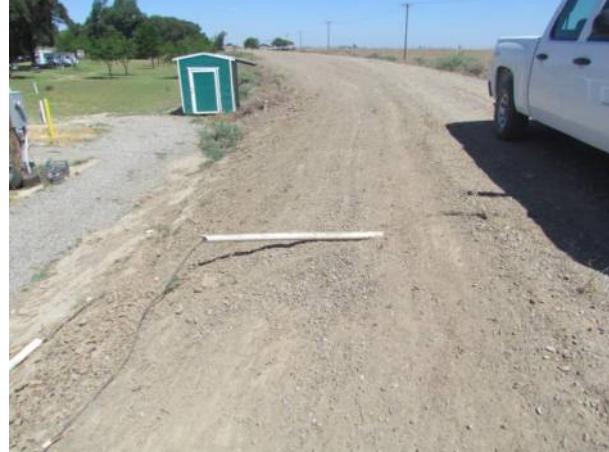
Levee Mile Report Line	27
Start Levee Mile	4.04
End Levee Mile	4.04
Location	Water Side
Category	Earthen Levee
Item	Encroachments
Looking north at electrical conduit on waterside slope.	
richard_s_20120529_453.jpg

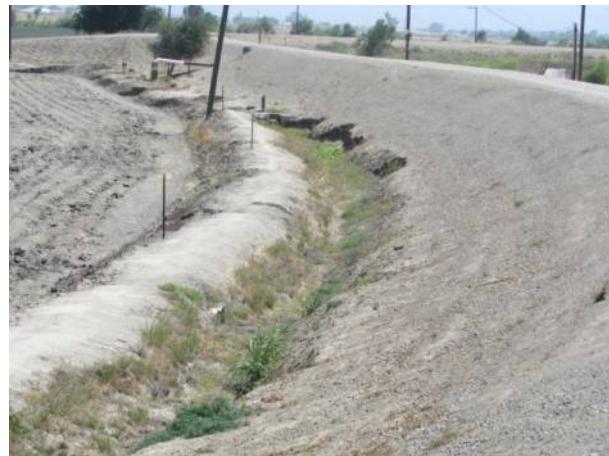
Levee Mile Report Line	29
Start Levee Mile	4.54
End Levee Mile	4.61
Location	Land Side
Category	Earthen Levee
Item	Encroachments
Looking south at irrigation ditch and erosion at landside toe.	
richard_s_20120529_454.jpg

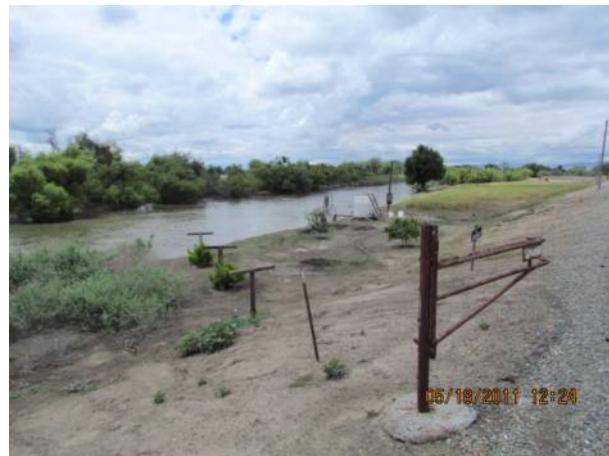
Levee Mile Report Line	30
Start Levee Mile	4.68
End Levee Mile	4.68
Location	Water Side
Category	Earthen Levee
Item	Encroachments
Looking south at grapevines and fruit trees on waterside berm.	
richard_s_20120313_135.jpg

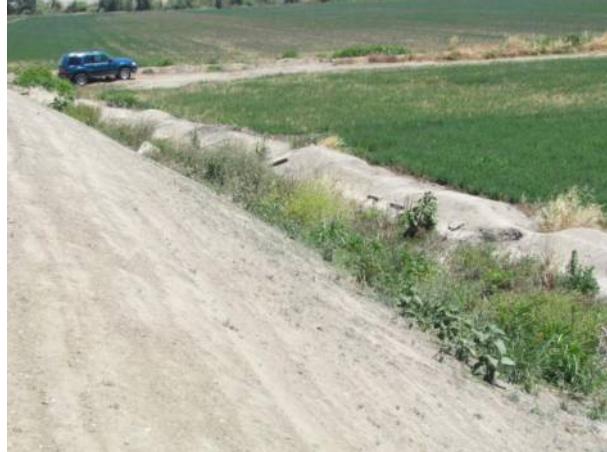
Levee Mile Report Line	32
Start Levee Mile	5.05
End Levee Mile	5.11
Location	Land Side
Category	Earthen Levee
Item	Encroachments
Looking northeast at irrigation ditch at landside toe.	
richard_s_20120529_455.jpg

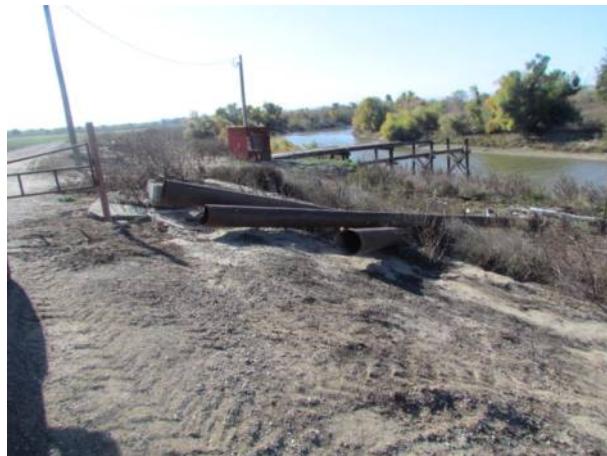
Levee Mile Report Line	33
Start Levee Mile	5.12
End Levee Mile	5.12
Location	Water Side
Category	Earthen Levee
Item	Encroachments
Looking north at abandoned pipes on waterside slope.	
richard_s_20120313_131.jpg

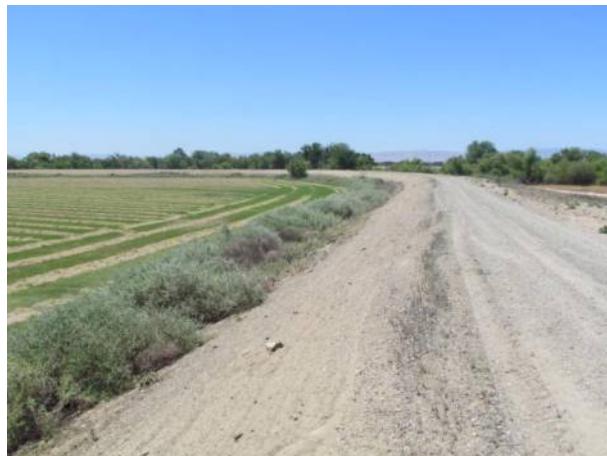
Levee Mile Report Line	38
Start Levee Mile	6.15
End Levee Mile	6.36
Location	Land Side
Category	Earthen Levee
Item	Vegetation
Looking south at dense vegetation on landside toe.	
richard_s_20120529_457.jpg

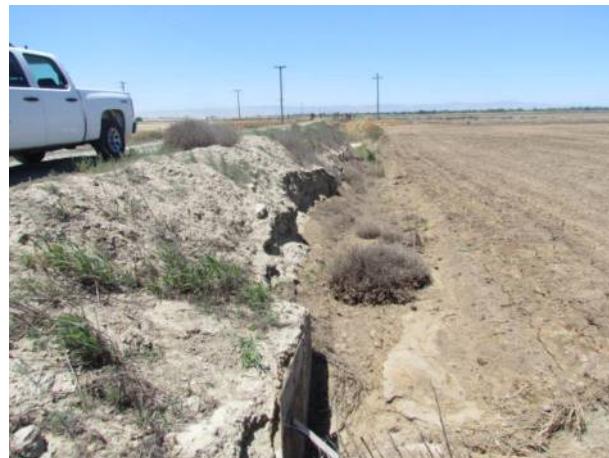
Levee Mile Report Line	49
Start Levee Mile	9.67
End Levee Mile	9.67
Location	Land Side
Category	Earthen Levee
Item	Erosion / Bank Caving
Looking northwest at landside erosion at levee toe.	
richard_s_20120529_459.jpg

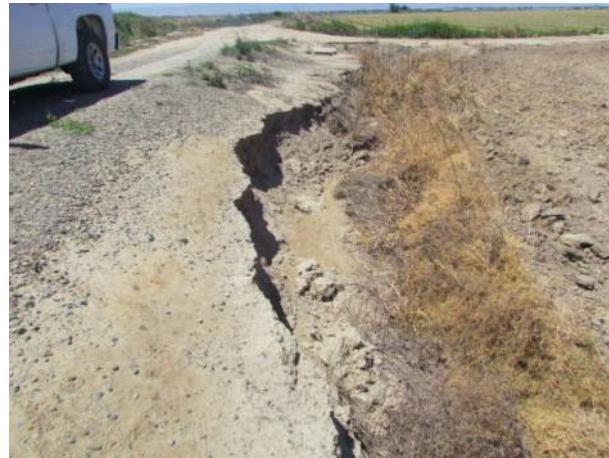
Levee Mile Report Line	50
Start Levee Mile	10.40
End Levee Mile	10.40
Location	Land Side
Category	Earthen Levee
Item	Erosion / Bank Caving
Looking northwest at landside erosion at levee toe.	
richard_s_20120529_460.jpg
